C9800/ES3640e NBC 2
Product Information Document

ETSC: Customer Support
July 2006

Rev 3.0

European Technical Support

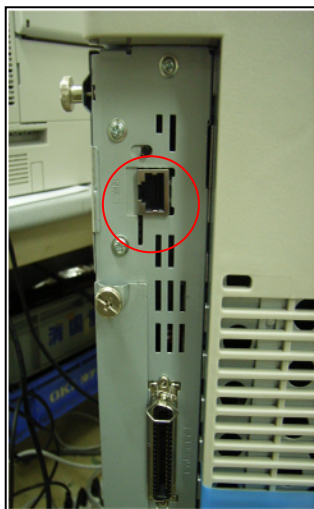
The current CU board (Aspen) has the Network socket in the position shown below:

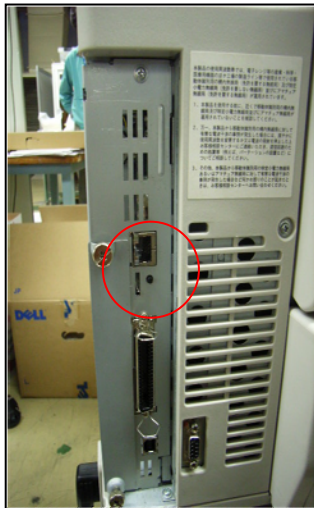
If the unit is RoHS compliant it will have the Aspen-2 CU board fitted and the Network socket will have moved to the new location shown below:

On the Aspen-2 CU board the location of the network socket is closer to the centre of the side plate and the Centronics (Parallel) port. It can also be noted that there are three grills visible above the Network port on the new board whilst previously there was only one.

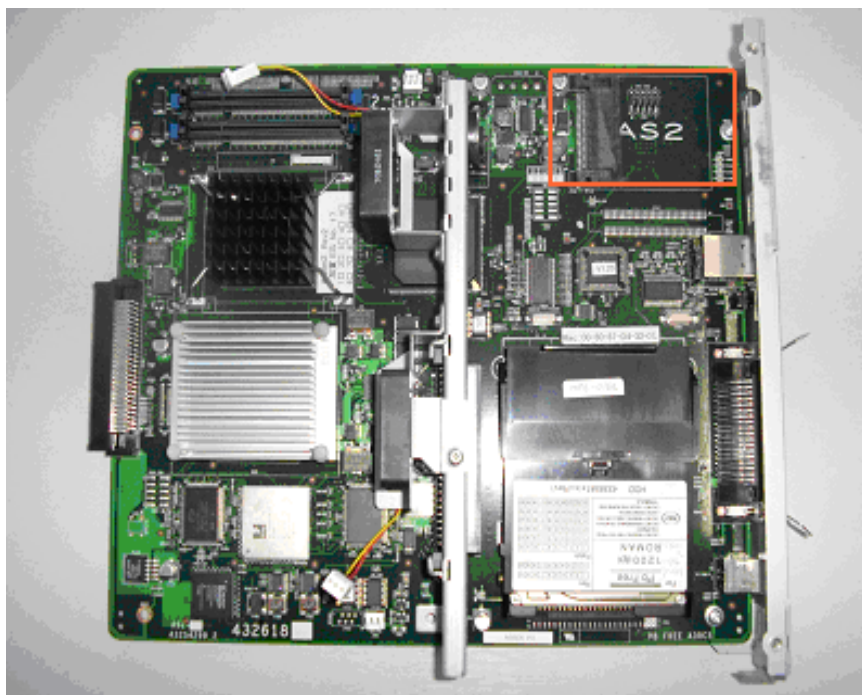
ASPEN2 CU Board

The most obvious visible differences between these two boards are:

- The Aspen 2 board (new) has the letters "AS 2" clearly marked on the top right corner of the board

- The Aspen 2 board has a large silver heat sink over it's CPU
- The Aspen 2 board has no additional network card board as the Ethernet port is integrated on the board itself.
